WASEL RESERVOIR DAM

CT. 00260

PHASE I INSPECTION REPORT
NATIONAL DAM INSPECTION PROGRAM

DECEMBER 1978

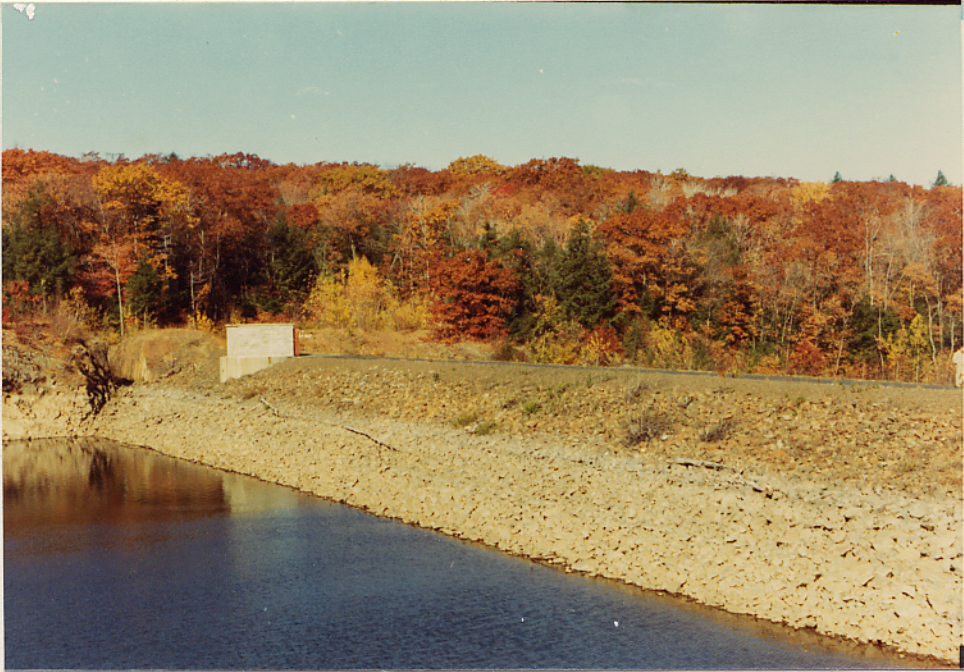
Overview from right abutment

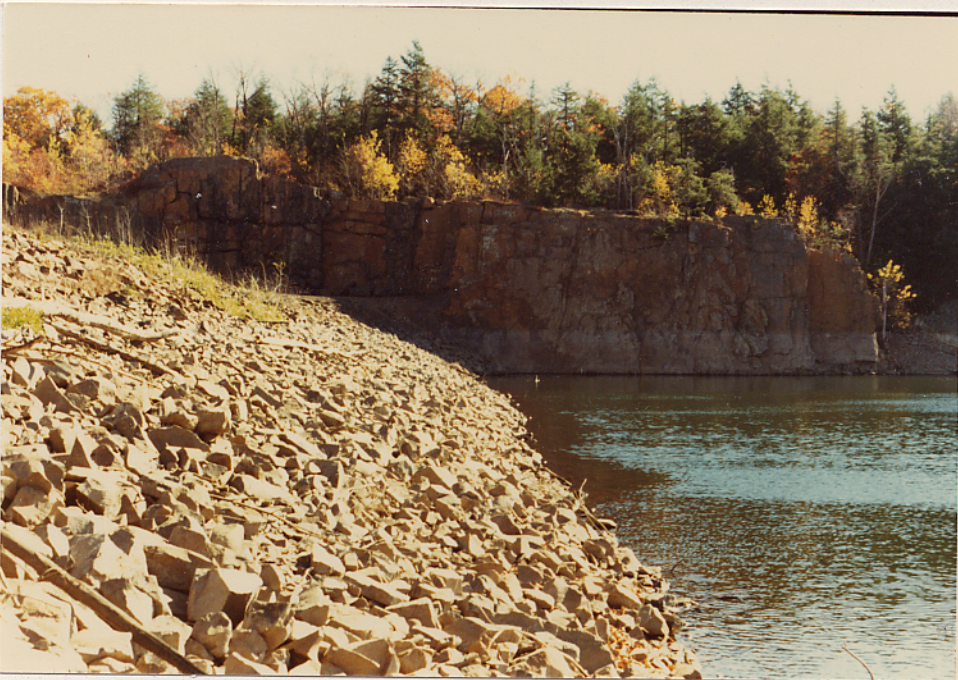
Overview from left abutment

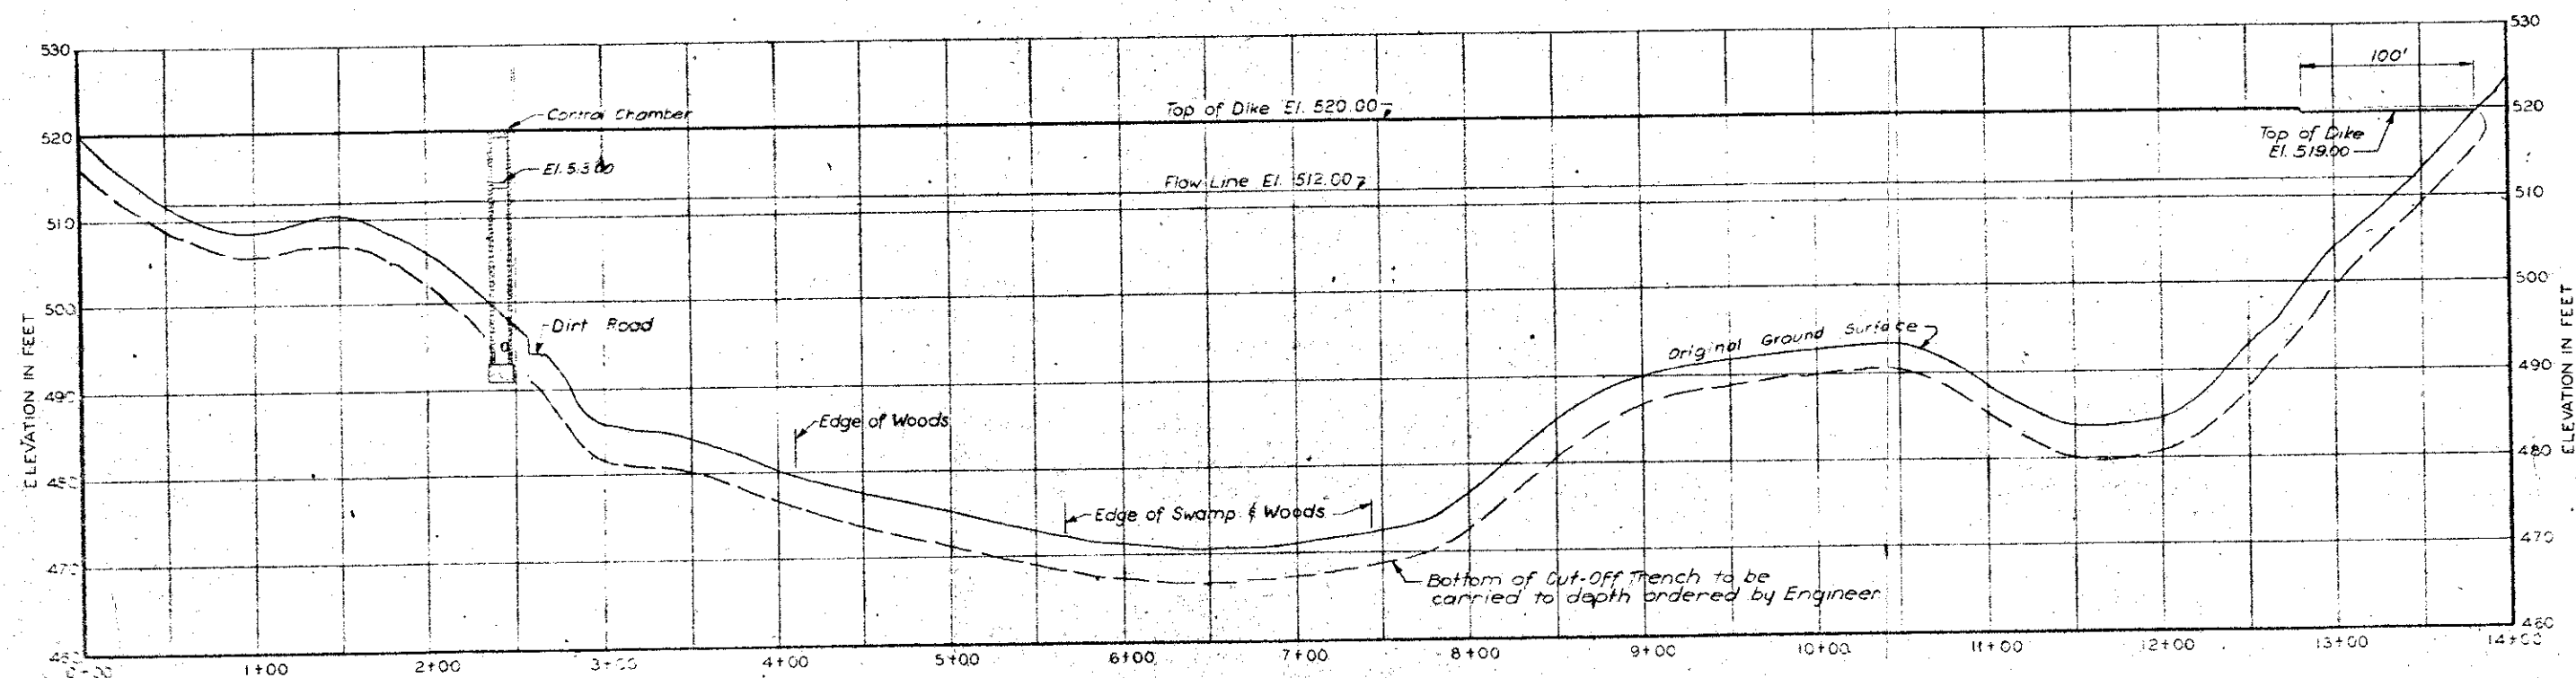
CENTERLINE PROFILE OF DIKE
SCALE: HOR. 1" = 50', VERT. 1" = 10'

The downstream face of the dike does not show any signs of sloughing. The upstream rip rapped face of the dike appears to be in excellent condition.

Dike (a 60 foot earth dam) was found to be very wet at the downstream toe in several areas, indicating extensive seepage. Because of the high fine content in the earth material used to construct the dam, I think the design engineers should be informed of this condition.
